REFERENZA TECNICA - TECHNICAL REFERENCE

Rehabilitation of  
**Menjil Dam**  
Sefid-Rud river, Iran

**Grouting**  
**Anchors**

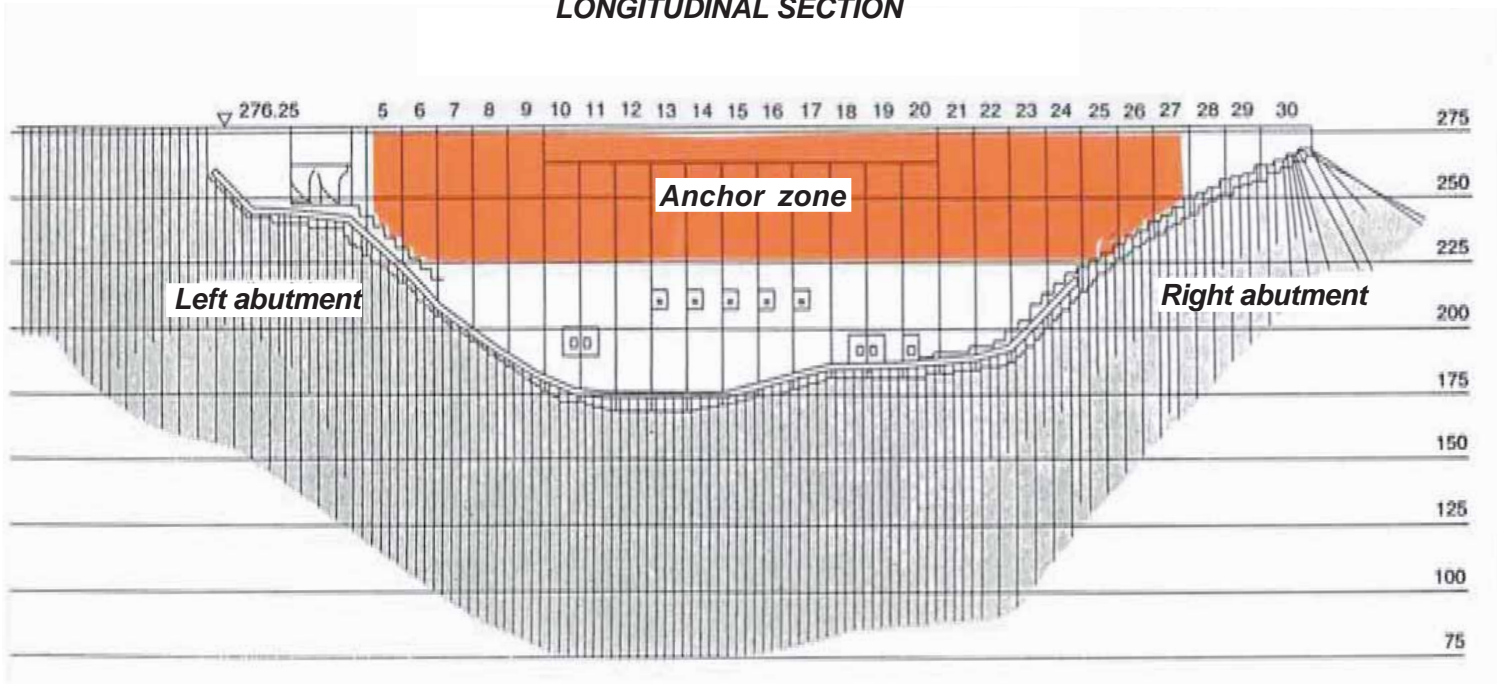
### LONGITUDINAL SECTION

The dam did not show evidence of irreparable structural damage such as to impair its stability, but the buttress upper part showed cracks, mostly horizontal, up to 2 cm wide, going from upstream to downstream, and reaching 20-25 m from the dam crest. In addition, so that displacements of 1.5 to 2 cm of the concrete were detected along the working joints. Immediate rehabilitation measures were required to assure regular impounding during the forthcoming 1991 season, the harvest would not be compromised.

The treatment consisted of repair to the cracks, in order to avoid water seepage and restore the monolithism of the structure. In addition, anchors were foreseen, to be installed below the cracks, from the dam crest to the embankment, to increase the safety coefficient against fissuring, should a new earthquake occur.

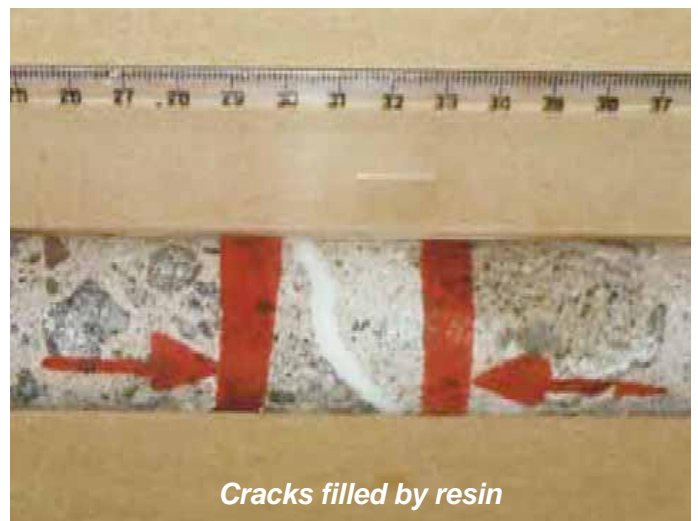
Upon completion of the treatment, a series of check holes was drilled: the cores recovered showed that concrete working joints as well as the secondary fissures were perfectly bonded

Cracks filled by resin

water takes were measured between 51 l/min and 0.4 l/min. Lower values were disregarded by the engineer, who considered it unnecessary to treat these concrete workingjoints. Epoxy resin with inorganic filler was used in conjunction with specific studied procedures to bond the two faces of the concrete fissures.

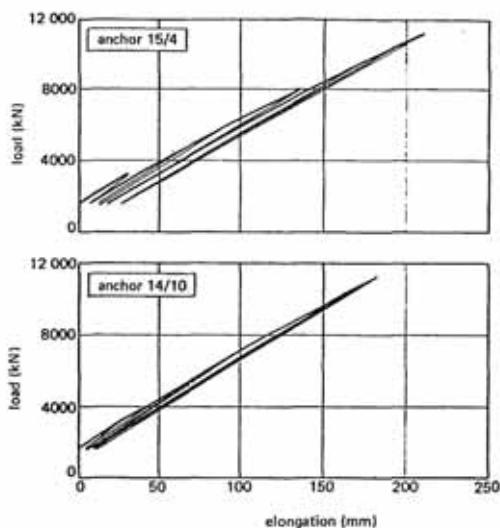
### Test anchors: LOAD/ELONGATION DIAGRAMS

The maximum load of 11200 kN (80% breaking load) was reached with 5 steps of 1600 kN and two of 800 kN, starting from an alignment load of 1600 kN. The load at the intermediate steps was kept constant during either 5 or 15 minutes and at the maximum load for 50 minutes. At the end of the test the locking load was applied. Anchor N.4 of buttress 15 (40.84 m) and anchor N. 10 of buttress 14 (38.25 m) were tested obtaining results complying with the assumed conditions:

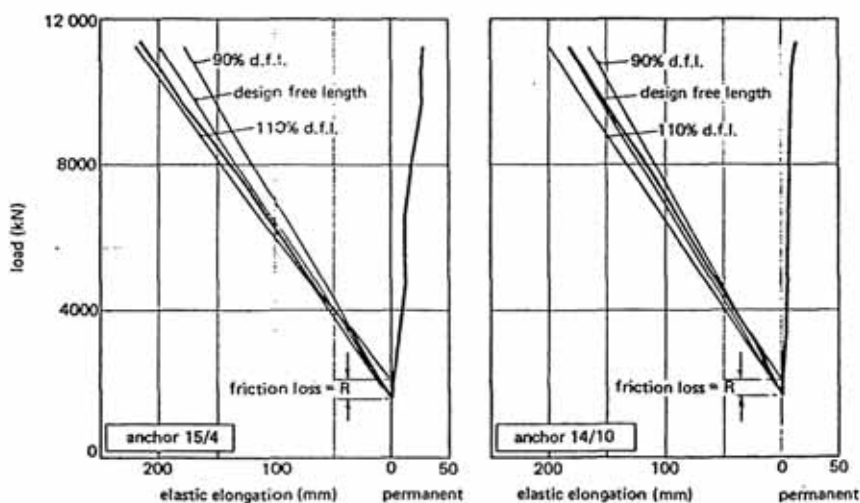
### Test anchors: ELASTIC AND PERMANENT ELONGATION Versus LOAD DIAGRAMS

✘ deformation increased less than 2% of calculated elastic elongation at 5' observation time or less than 1% at 15'

✘ angles tangent ratio between reloading and unloading curves not smaller than 0.9

✘ apparent free tendon length, calculated by the straight line of diagram of the elastic deformations should be done to the theoretical one; the actual values, expressed as percentage of the theoretical ones, were respectively 99% and 100%.

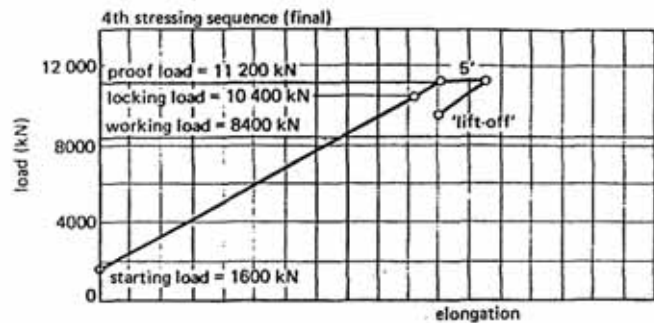
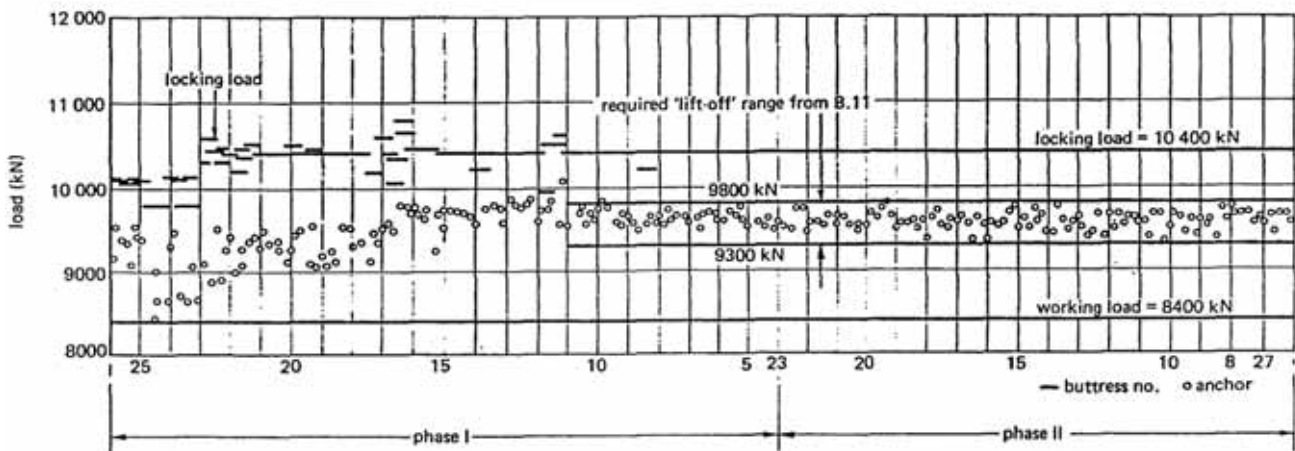
## LIFT-OFF RESULTS

by means of lift-off test. All the recorded lift-off values are represented in figures and they show the decrease in scattering achieved after the final stressing sequence was adopted.

performed a few hours after stressing. This measurement was then compared with a reading taken five days later. The loss of load between the first two readings being lower than 1 per cent, the cutting of the protruding strands and all the finishing operations could start for all the anchors of the same buttress. A monitoring programme including monthly readings was implemented and results obtained until the completion of the anchors contract are shown in the figures. It can be seen that the load losses are within acceptable limits as required by FIP Recommendations.
