## Propping Up The Leaning Tower of Pisa

By Federico Pagliacci and Vincent Jue

*The following article which comes to us from ADSC International Members Trevi S.p.A. and Soilmec, highlights the innovative repairs undertaken at the iconic, Leaning Tower of Pisa in the early 2000s. I happened to be at the site towards the end of the project described as I was visiting Pisa on my way to a meeting of the International Society for Micropiles that was held in Venice, Italy. (Administered by the ADSC Planning Staff, ISM's most recent meeting was held in Krakow, Poland in early June of this year). At the time of my visit the "Tower" had just been opened to the public and Trevi's equipment was still on site. I'm not sure if the "Tower" is one of the "Eight Wonders of the World," but the fact that it is still standing, though on a dramatic tilt is a wonder indeed. When ascending the spiral staircase to the top one goes from leaning to the left to leaning to the right and back and forth until one reaches the observation level from which you can look out on the medieval town of Pisa. It is an impressive sight from an impressive structure. (Editor)*

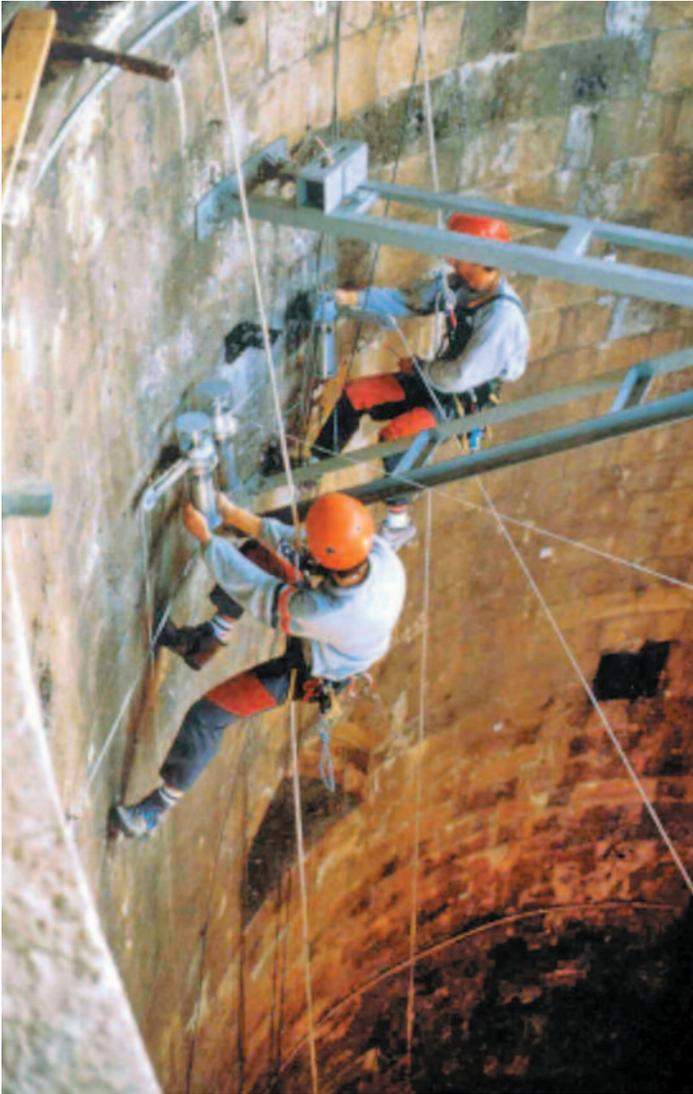
*Installation of complex monitoring equipment to allow continuous measurement of the Tower's displacements, rotations, stresses, temperatures and vibrations.*

The first step was to install a complex monitoring system to continuously measure many Tower parameters, including displacements, rotations, stresses, temperatures, and vibrations. In

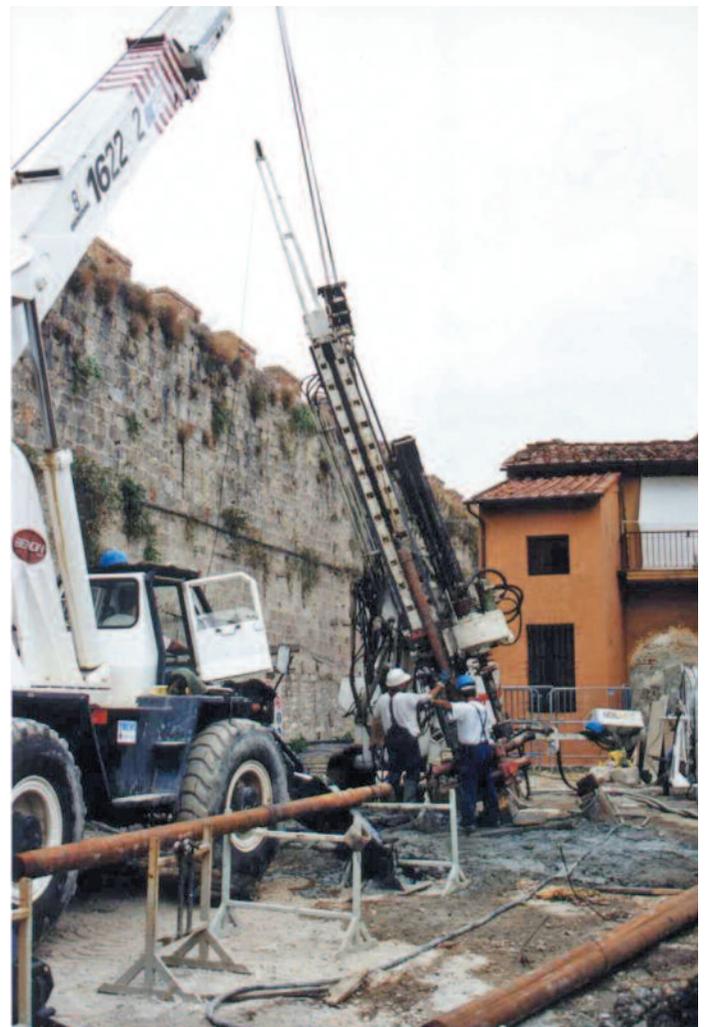
*Temporary rigging trestle used to attach a backstay to the Tower, to prevent potential movement of the Tower during restoration operations.*

In 1998 a system of temporary rigging trestles was put in place to help prevent any potential movement during restoration operations. Two sub-horizontal steel backstays were connected to the Tower at the third story utilizing two metal frames on the north side. The trestles were supported by 108 ft long micropiles that were drilled using a Soilmec SM-405 rig\*. In the event of adverse movements of the Tower, this safeguard cabling could be tensioned to hold the Tower in place. The maximum force that could have been exerted by each of the backstays equaled a force of 150 tons. At most a 120 ton-force was applied.

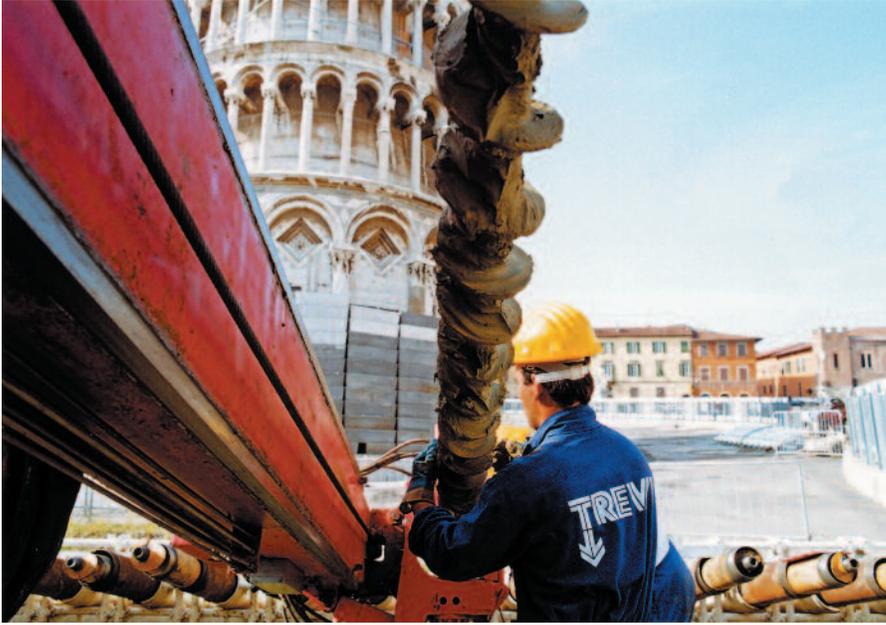
Soil excavation from under the Tower during the final geotechnical stabilisation.

soil extraction was selected, using soil extraction tubes installed adjacent to, and only beneath the north side of the foundation. This plan was arrived at by the application of physical models and advanced numerical analysis. The team determined that the soil extraction had to take place north of a critical line located about half a radius from the northern edge of the foundation. This was undertaken to maintain Tower stability.

Forty-one temporary extraction holes were then installed on the north side of the Tower at a depth of 64 ft, spaced 1.6 ft apart, and at an inclination angle of 30 degrees. The top section of each borehole featured an 8.7 in diameter fixed casing, 50.8 ft in length, followed by a lower borehole section with a 6.6 in casing. The lower borehole sections were beneath the Catino and Tower plinth. The Tower's northward rotation increased on average by 6 arc seconds per day brought about by the removal of approximately 127 qt of soil.

Upon completion, the Tower rotated toward the North by about 1,800" returning to the position recorded 200 years earlier. In ad-

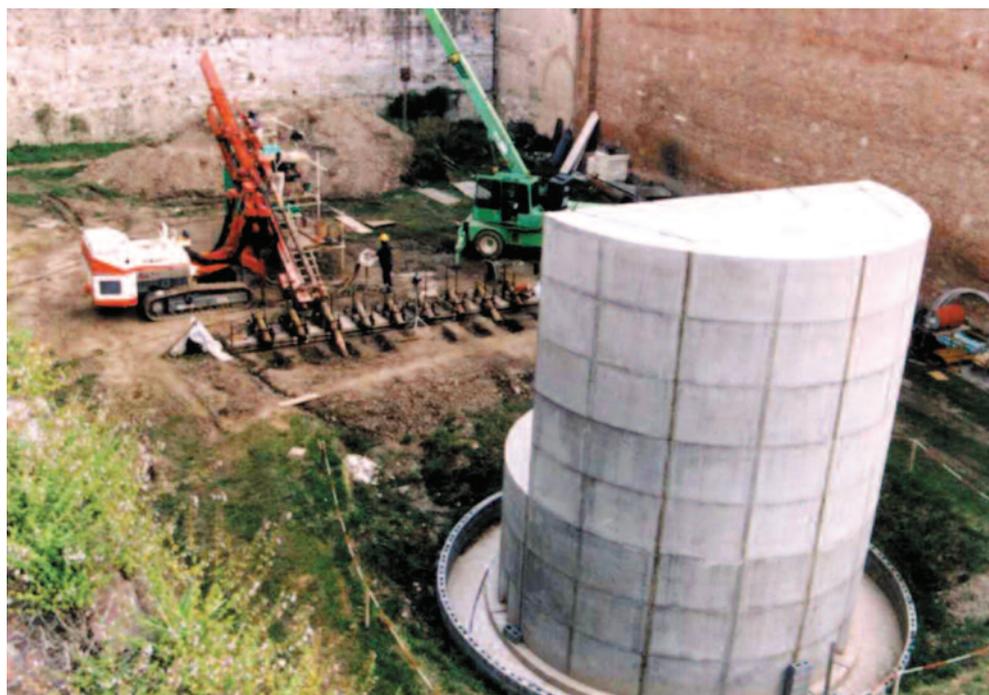
Large-scale field test performed in the Piazza.

A large-scale field test was performed in 1995-1996 in order to verify that it was truly feasible to extract soil without triggering a Tower collapse. In the Piazza, Trevi built a 23 ft diameter circular foundation of reinforced concrete at approximately 4.9 ft below ground. On top of this foundation Trevi built a structure composed

of over 150 concrete blocks geometrically placed so as to simulate the Tower's pressure distribution on the ground. Instrumentation was installed in the concrete and soil to monitor settlements, rotation, contact pressure, and pore pressure during and after the soil extraction tests. The procedure had to allow for extracting soil with precise control and without causing vibrations.

For this delicate under-excavation work a drill that could advance without disturbing the surrounding ground was required. Trevi used the newly-developed Soilmec SM-405\* drill rig with a hollow-stemmed continuous flight auger (CFA) housed inside a 7 in counter-rotating diameter casing instrumented with a probe sensor that was mounted onto the drill bit.

During soil excavation, the casing, auger and probe were advanced 64 ft at an inclined angle of 30 degrees with respect to ground level. The casing and auger were then withdrawn while

counter-rotating thus creating an 18 qt borehole. During extraction, the probe was left in place so that the probe sensors could measure the controlled-collapse of the borehole which occurred a few minutes later.

This large-scale in-situ experiment demonstrated that the boreholes closed gently and that repeated extractions could be made from the same location. The experiment validated that soil could be safely extracted from beneath the Tower using their newly-developed equipment, drilling procedure, and communications plan.

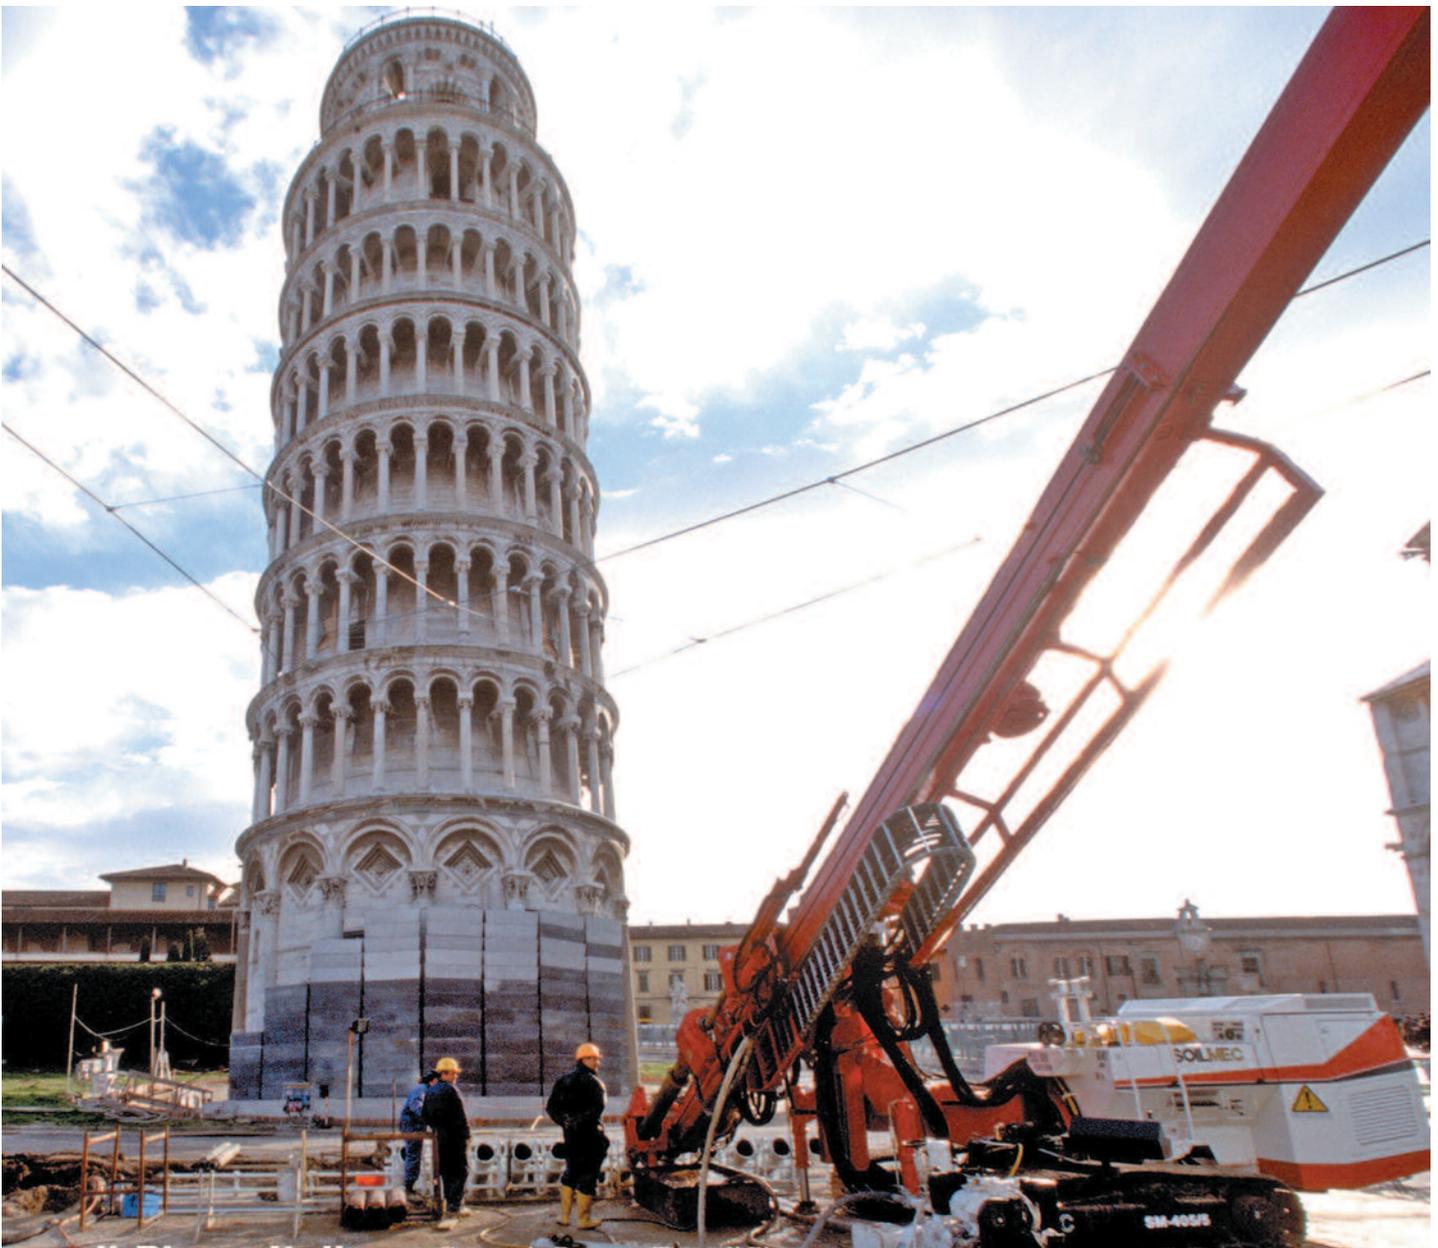
*The temporary post-tension concrete ring with lead blocks stacked on the north side of the Tower foundation. The backstay cables are also visible.*

1993, once this was in place, 600 tons of lead weights were applied to the north side of the foundation to counterbalance the overturning tilt of the Tower. This was accomplished by building a post-tensioned, removable concrete ring around the base of the Tower, where the lead weights were stacked. In order to make the concrete ring adhere to the Tower, it was tensioned using 6-thread steel cables fed through cavities within the concrete. In 1995, the lead weights were increased to total 1,000 tons.

When completed, this post-tensioned concrete ring slightly reduced the inclination of the Tower, and more importantly stopped its rotational motion. However, these unsightly lead weights provided only a temporary solution.
