Stockholm, Sweden

Jet Grouting Cut-Off Wall

| Cliente :<br>Owner: | RIKSDAGS ADMINISTRATION Real Estate Unit |
| Contrattista principale : Main Contractor : | NCC Construction Sverige AB |

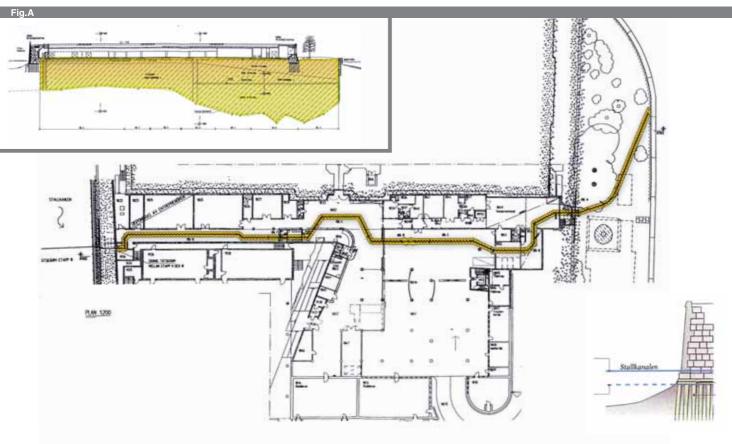
Fig.B

The cut-off has been designed about 150 m long, formed by two rows, 375 mm apart, of single fluid secant jet grouting columns, for a total of 515 units with a 1000 mm diameter at 750 mm centre to centre, connecting an existing weir on one side of the island and a new sheet pile weir on the other side. It had to penetrate the granite bedrock for 1.5 m, thus having a depth varying from 15 to 35 m and a total surface of about 2600 square metres.
