REFERENZA TECNICA - TECHNICAL REFERENCE

Rehabilitation of  
**Menjil Dam**  
Sefid-Rud river, Iran

**Grouting**  
**Anchors**

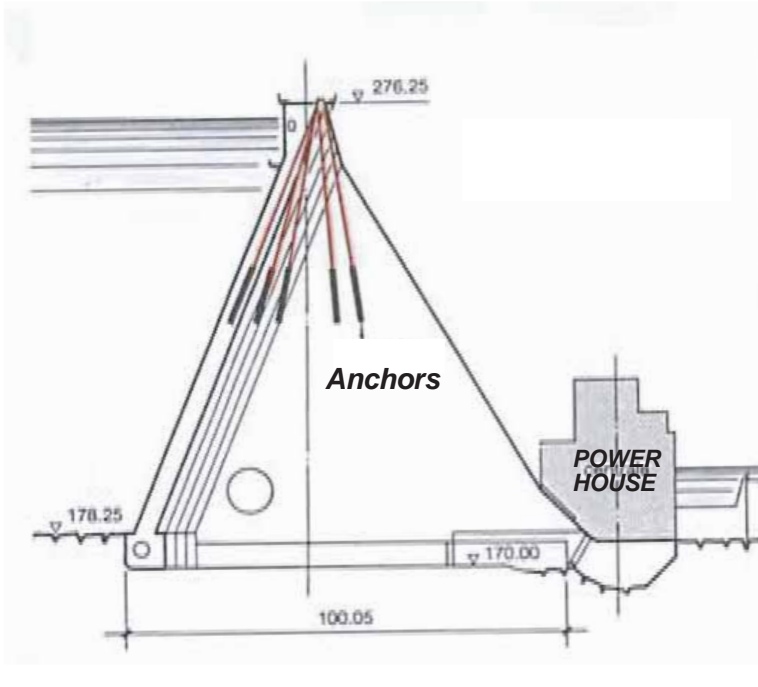
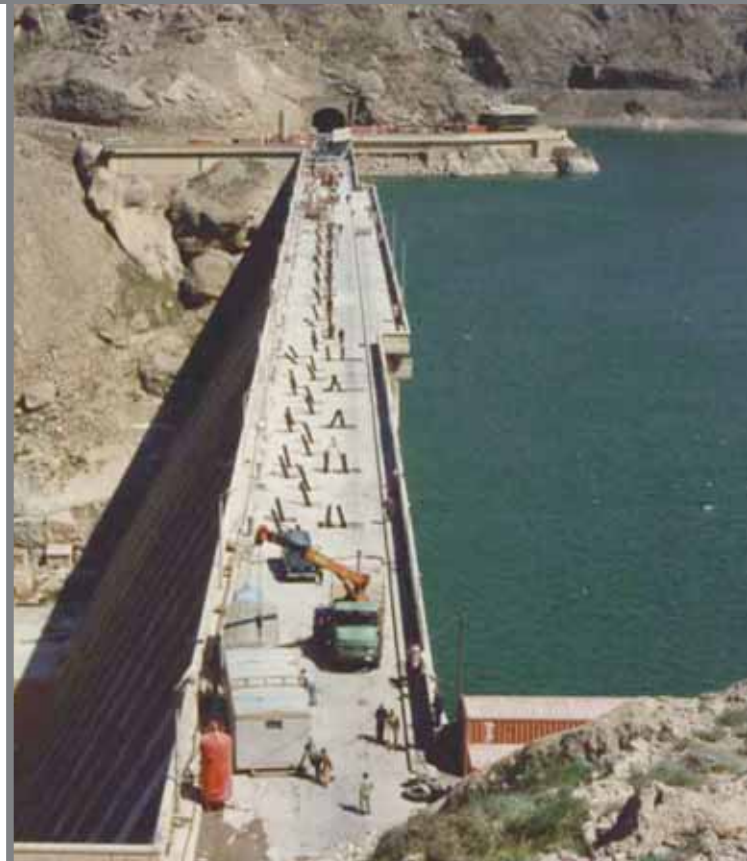
### CROSS SECTION

The dam did not show evidence of irreparable structural damage such as to impair its stability, but the buttress upper part showed cracks, mostly horizontal, up to 2 cm wide, going from upstream to downstream, and reaching 20-25 m from the dam crest. In addition, so that displacements of 1.5 to 2 cm of the concrete were detected along the working joints. Immediate rehabilitation measures were required to assure regular impounding during the forthcoming 1991 season, the harvest would not be compromised.

The treatment consisted of repair to the cracks, in order to avoid water seepage and restore the monolithism of the structure. In addition, anchors were foreseen, to be installed below the cracks, from the dam crest to the embankment, to increase the safety coefficient against fissuring, should a new earthquake occur.

- working load	8400 kN
- breaking load	14000 kN
- working/breaking load ratio	0.6
- average total length	40 m
- bond length	12 m
